Public Health Nuisance Assessment

Property Address: 5006 S. Elmhurst

Date and Time of Inspection: 11:30 am January 16, 2014

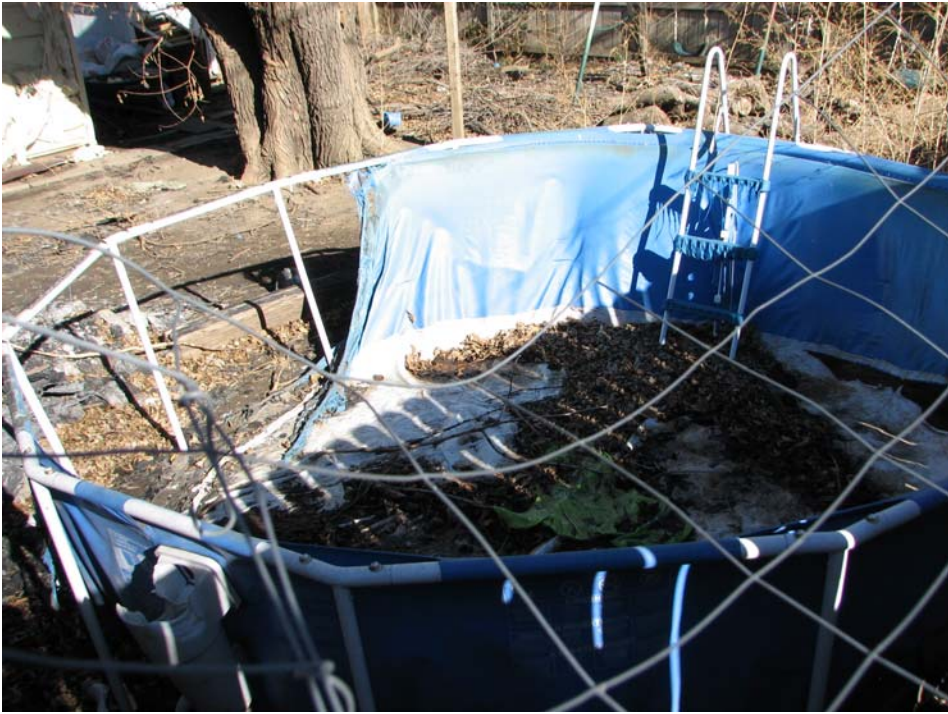
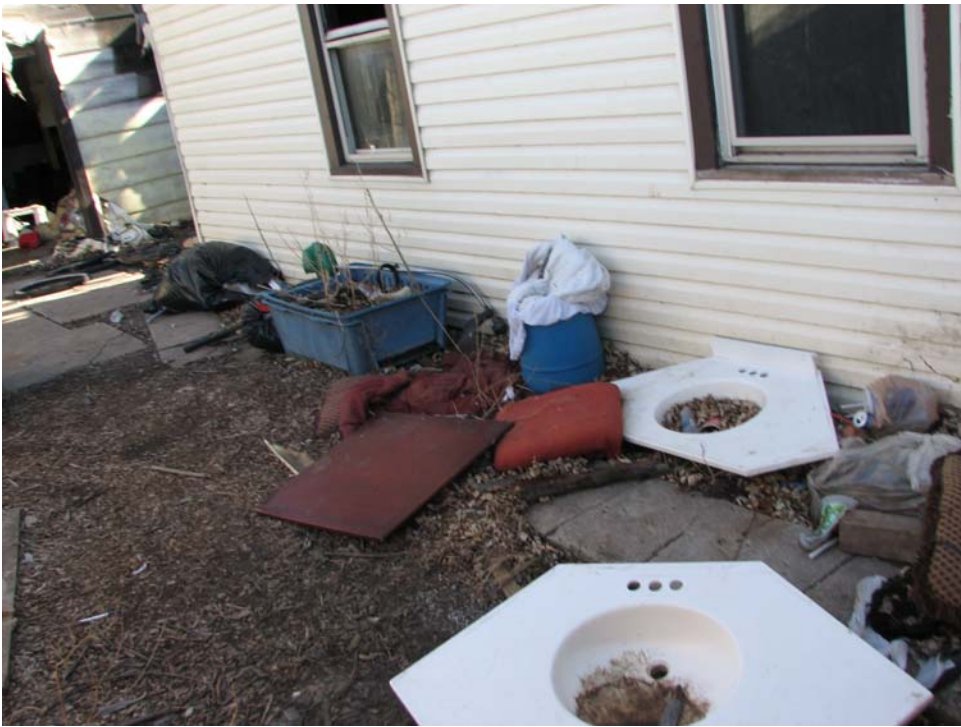
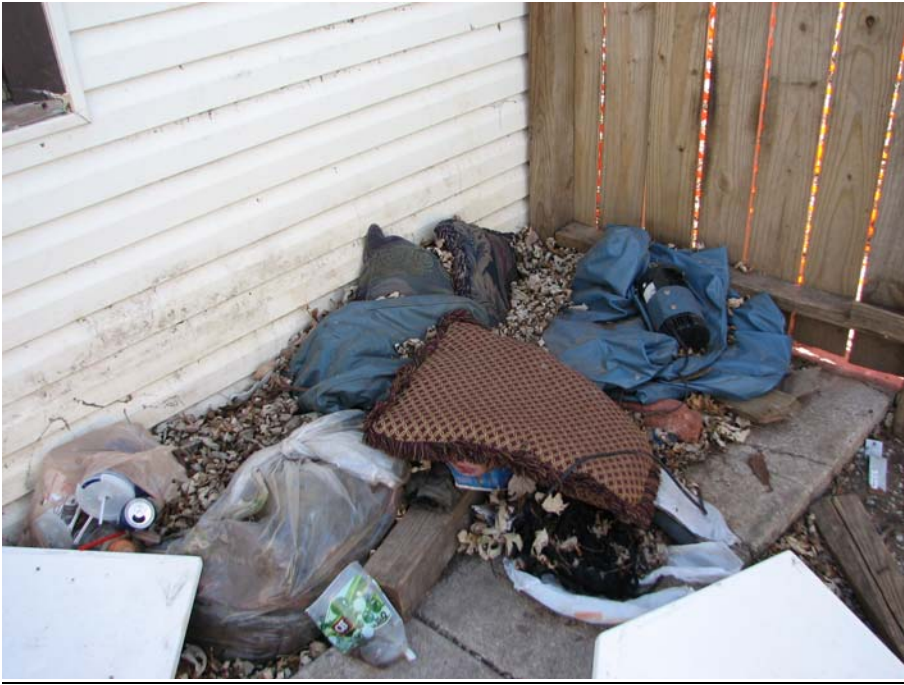
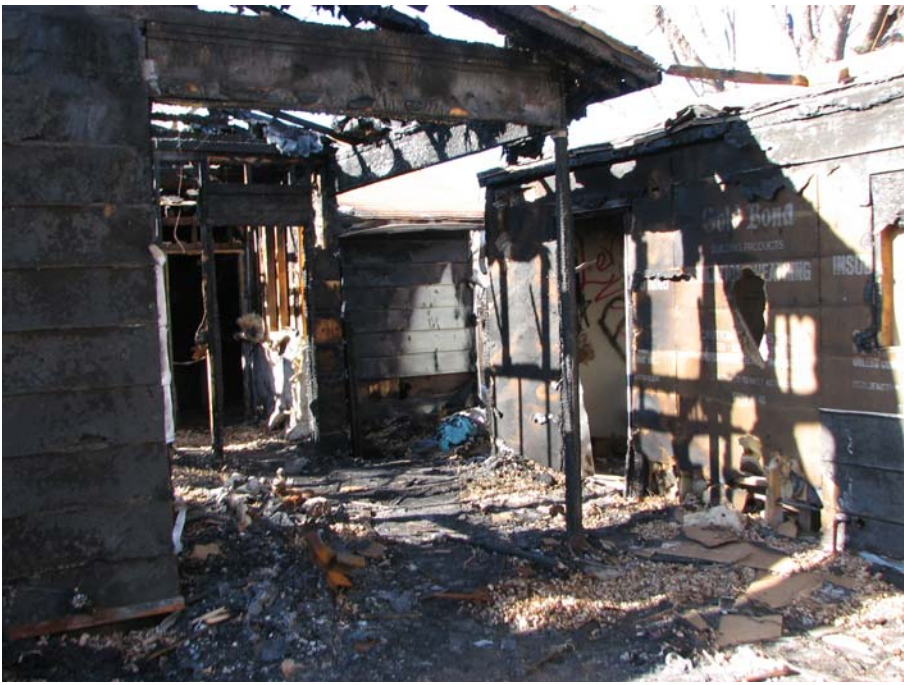
5006 S. Elmhurst – January 16, 2014

The house looks as though there is only minor damage from the street. Upon investigating the back, there are clearly major safety concerns. These safety concerns include but are not limited to:

- Area full of trip hazards caused by garbage, various uncommon outdoor items, and/or burnt housing material
- Burnt floor and floor boards with large portions of the floor missing over the basement presenting a fall hazard
- Burnt structural supports
- Open garage and shed with many trip hazards and sharp objects
- Broken Glass
- Open, uncovered basement windows
- Easy access to the back of the property

- Broken, above-ground swimming pool currently with shallow pools of water. As spring and summer come this will be an excellent breeding ground for mosquitos and the potential spread of West Nile Virus

- Piles of trash and/or debris
- Tall ground vegetation which appears to be dead at this time however will increase the varmint and fall hazards once spring approaches.
- At least one cat was present on site during the time of the visit, hidden in the shed.
